**ALUMINUM Mill**

Cumming, Georgia

25" Mill

Roll Alignment, Motor Alignment

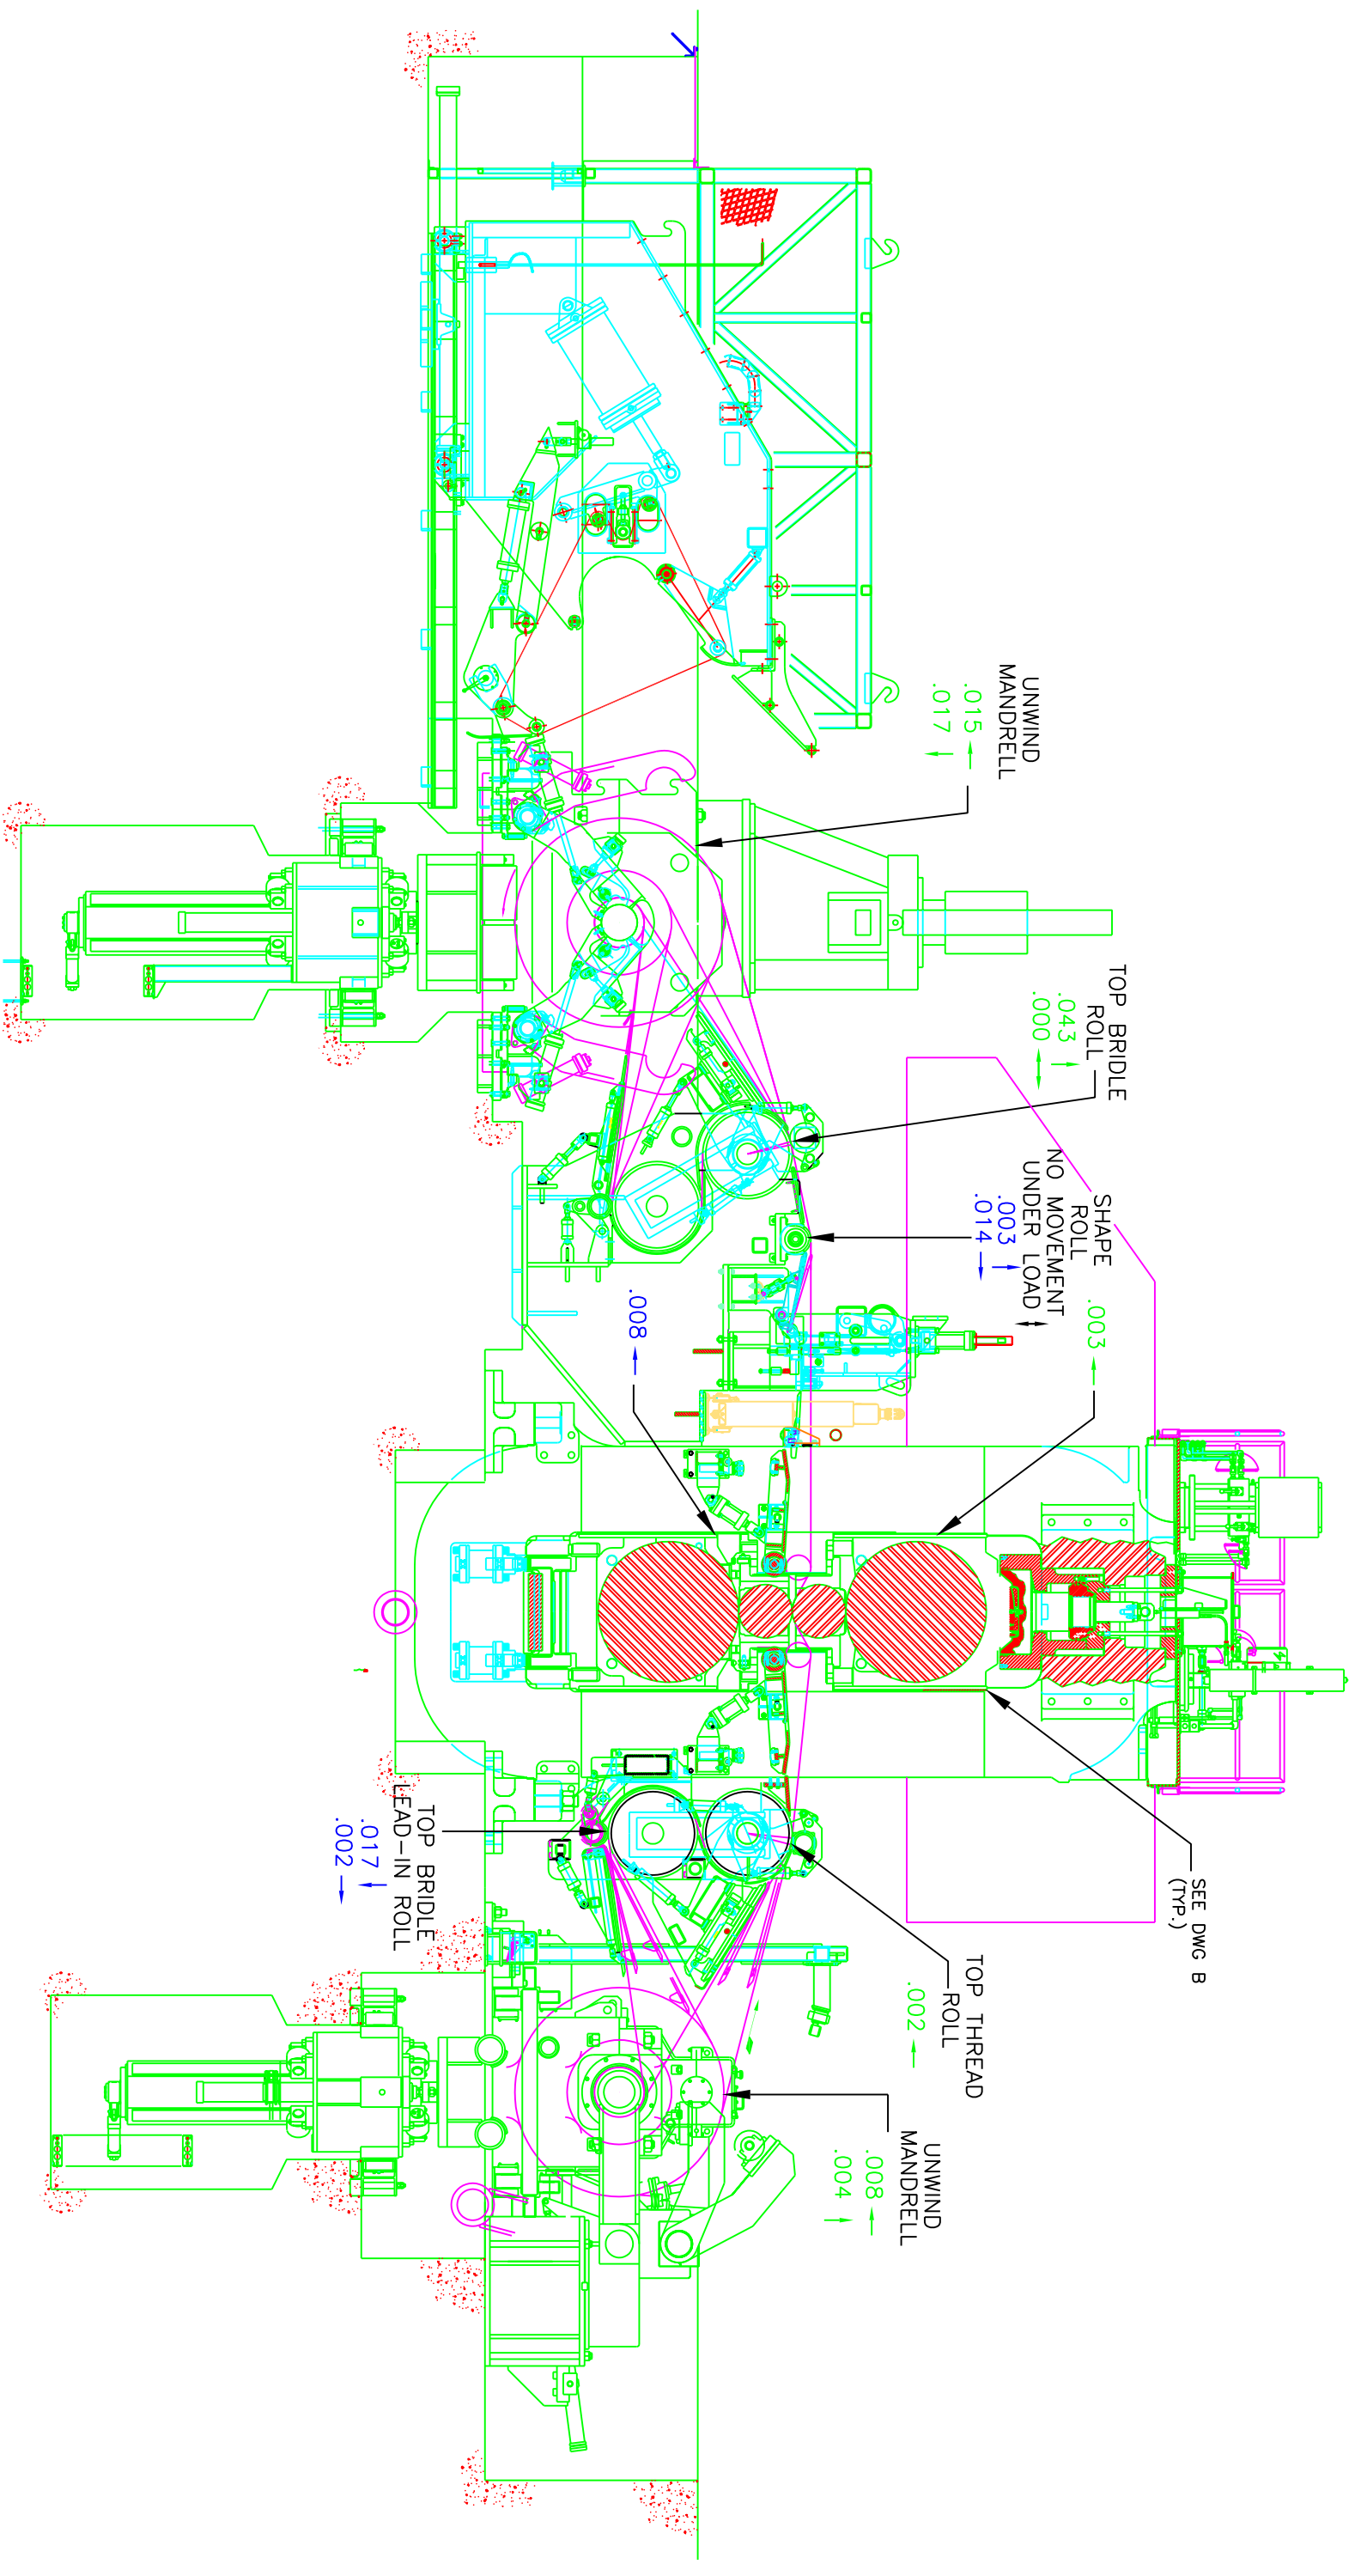
- ◆ SOS worked under the direction of Mr. Spencer Owens.
- ◆ SOS was instructed to assist the mill with the alignment of the Deflector Roll. The Datum for the inspection was the machined surface in the work roll window and gravity level. The Deflector Roll was aligned to be within .004", both vertically and horizontally.

- ◆ SOS then inspected the alignment of the Vidimon Roll and the Billy roll. The alignment of the Vidimon roll was found to be acceptable to the mill; however, the Billy Roll was found .060" out of alignment, which was unacceptable. This roll was corrected to be within .004".
